THEA FOSS AND WHEELER-OSGOOD WATERWAYS
REMEDIATION PROJECT

YEAR 12 MONITORING
LONG-TERM MONITORING PLAN
EVENT REPORT

NOVEMBER 16, 2018

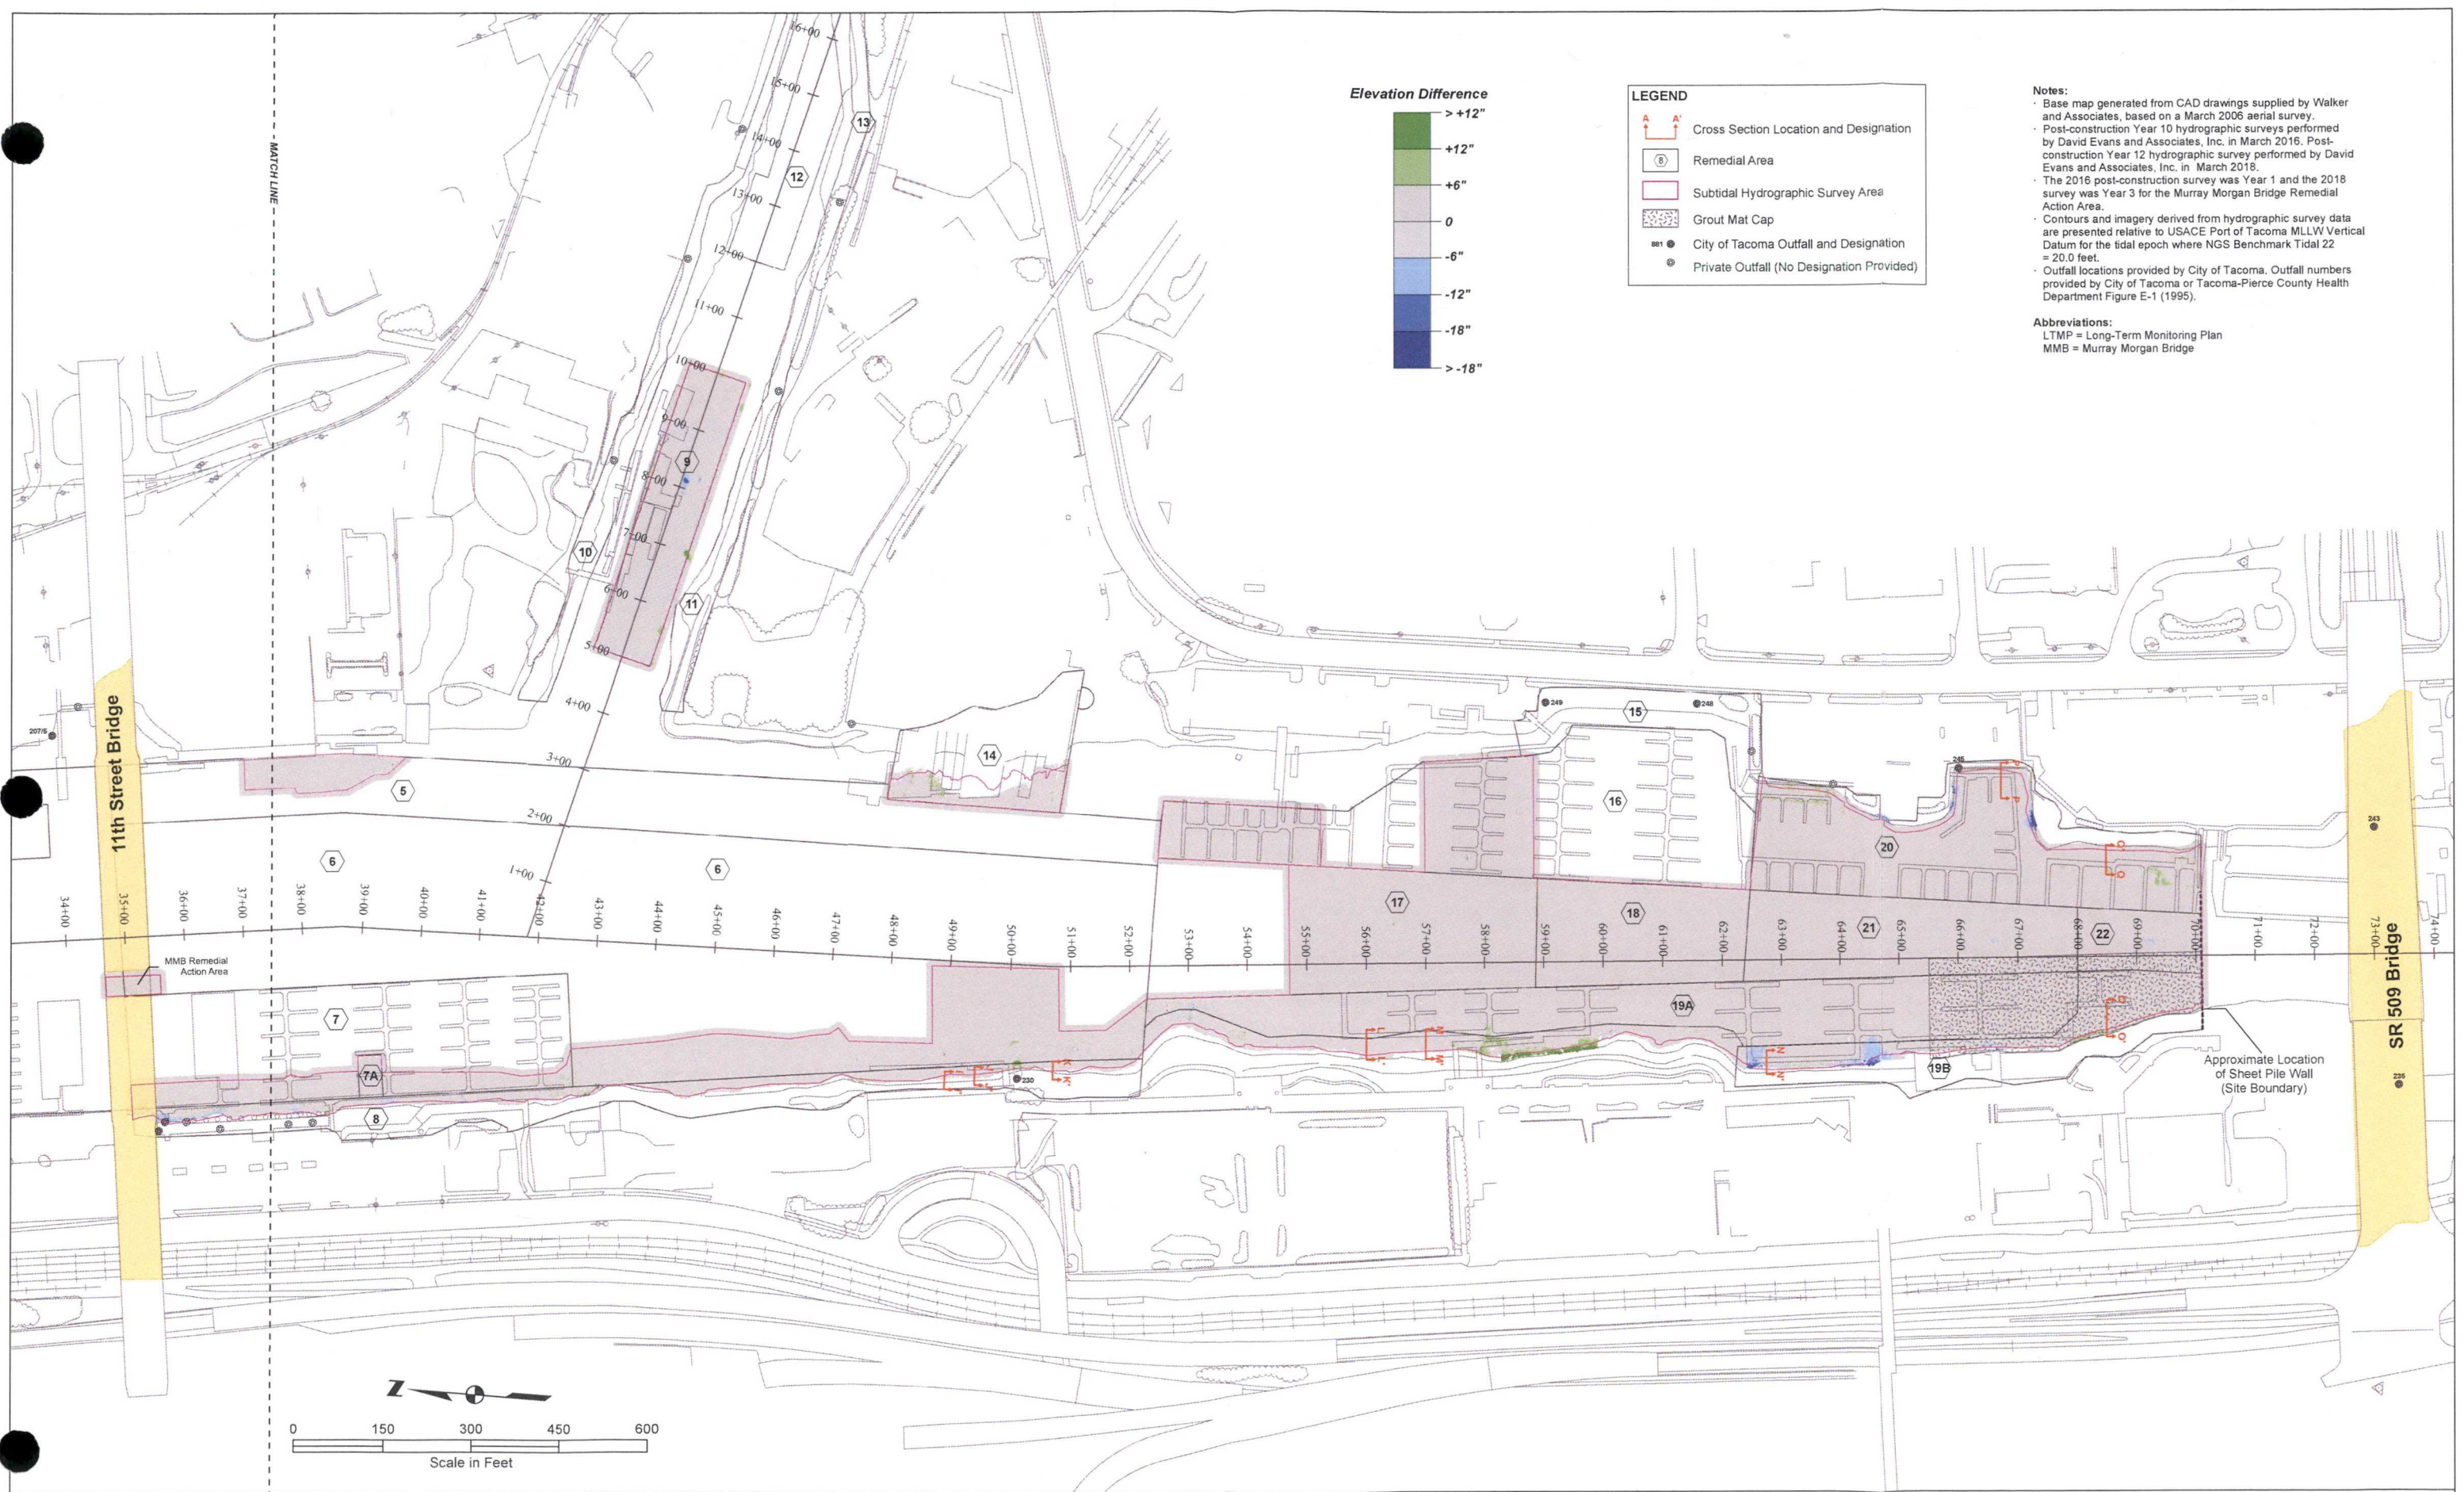
Figure 2-3 (Page 1 of 2)
Comparison of Year 10 (2016) and Year 12 (2018)
Subtidal Hydrographic Survey Results

- A comparison of the Year 10 survey to the Year 12 survey shows that the elevations in most areas have remained fairly consistent and stable during the past 2 years (refer to Figure 2-3).

- When comparing the Year 10 and Year 12 hydrographic survey results (refer to Figure 2-3), there were multiple slope cap locations that showed a decrease in the cap surface elevation along the upper boundary of the hydrographic surveys. These locations were present in RAs 1B, 3, 19B, and 20. These areas were all later visually inspected during the Year 12 low-tide slope cap inspections to determine if any apparent loss or erosion of material was occurring in these areas. Based on these Year 12 visual inspections, there was no apparent loss or erosion of material observed in any of these locations.

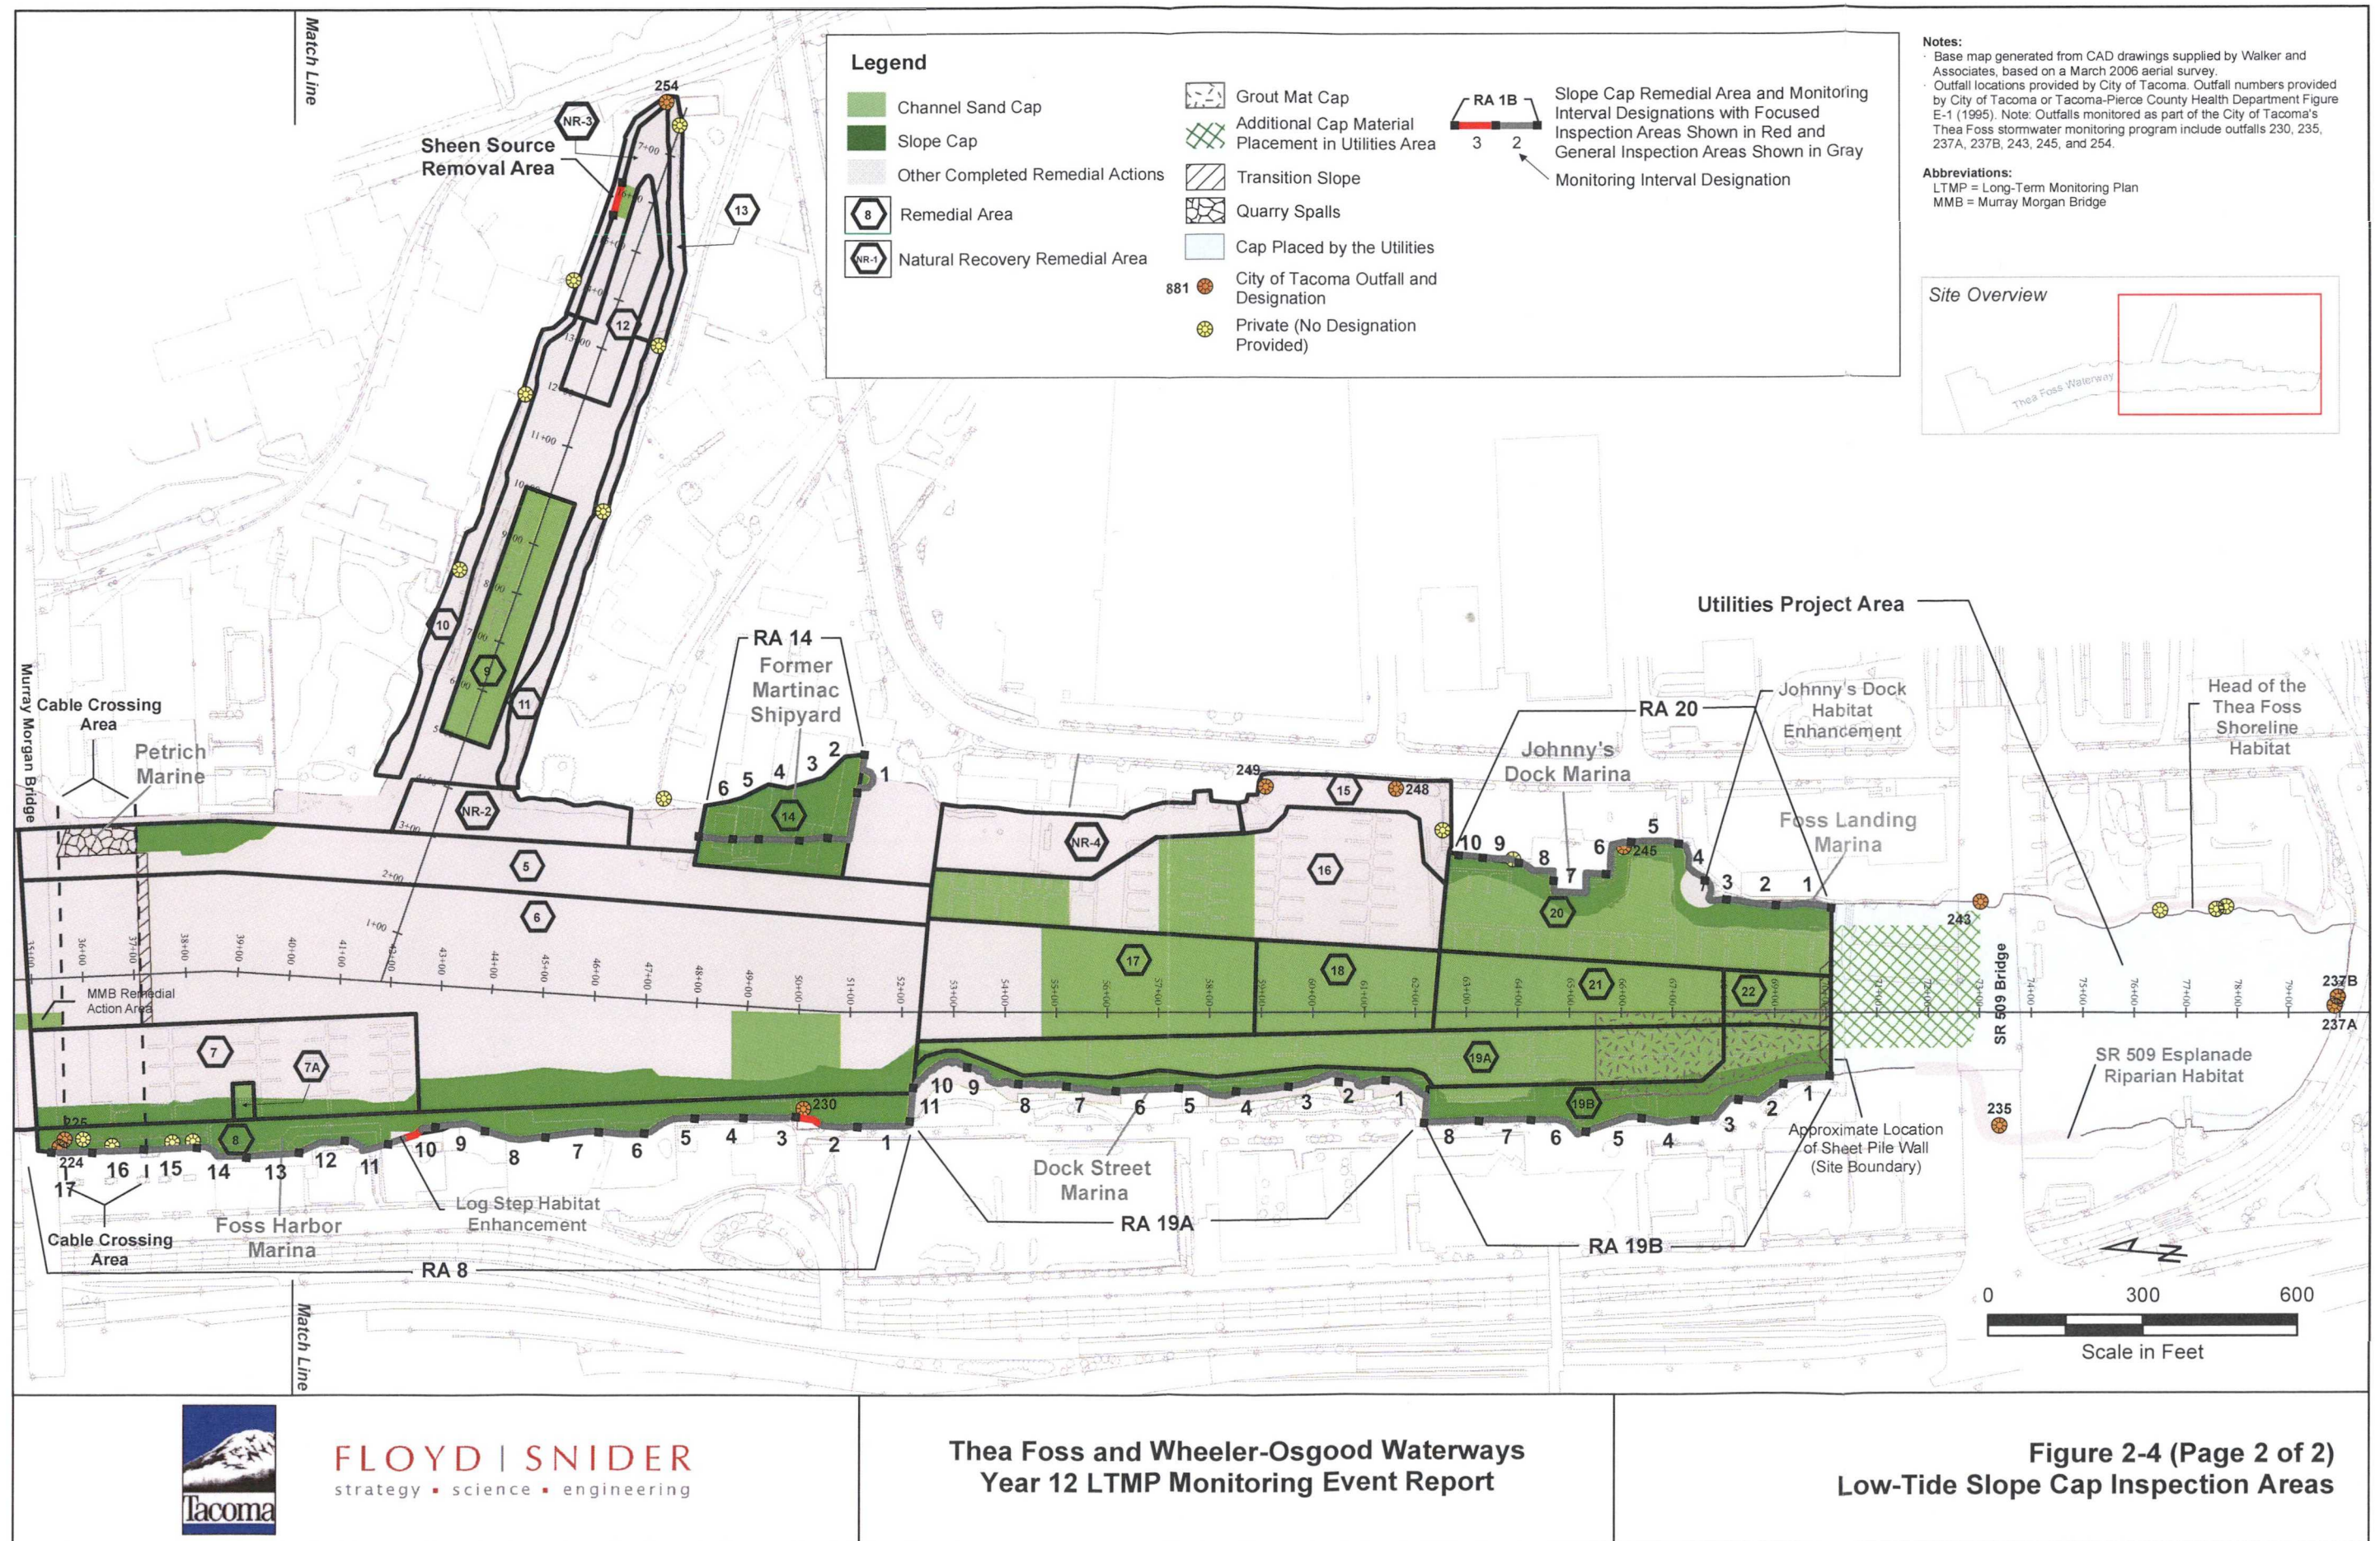
Figure 2-4 (Page 1 of 2)
Low-Tide Slope Cap Inspection Areas

Additionally, significant wave action during winter storms may have caused some movement of slope cap material in the northern half of this remedial area (Monitoring Intervals RA-1B-3 to RA-1B-5) over the past 12 years of monitoring, based on multiple observations (some potential downslope movement of riprap, missing sampling stakes, changes to the surface of the habitat mix bench in places, and photo comparisons of the slope cap over time). However, the cap appears to have remained intact and the integrity of the cap does not appear to be affected in this northern half of RA 1B. This conclusion is supported by a comparison of the results from the subtidal hydrographic surveys completed over the years in RA 1B, which have shown consistent elevations in this area over time, including the most recent comparison of Year 10 and Year 12 subtidal hydrographic survey results (refer to Figure 2-3). No response action is proposed for the northern portion of RA 1B at this time; however, this portion of RA 1B will continue to be monitored as a focused slope cap inspection area during future LTMP monitoring events.

The remaining slope cap areas within RA 3 had no deficiencies identified.

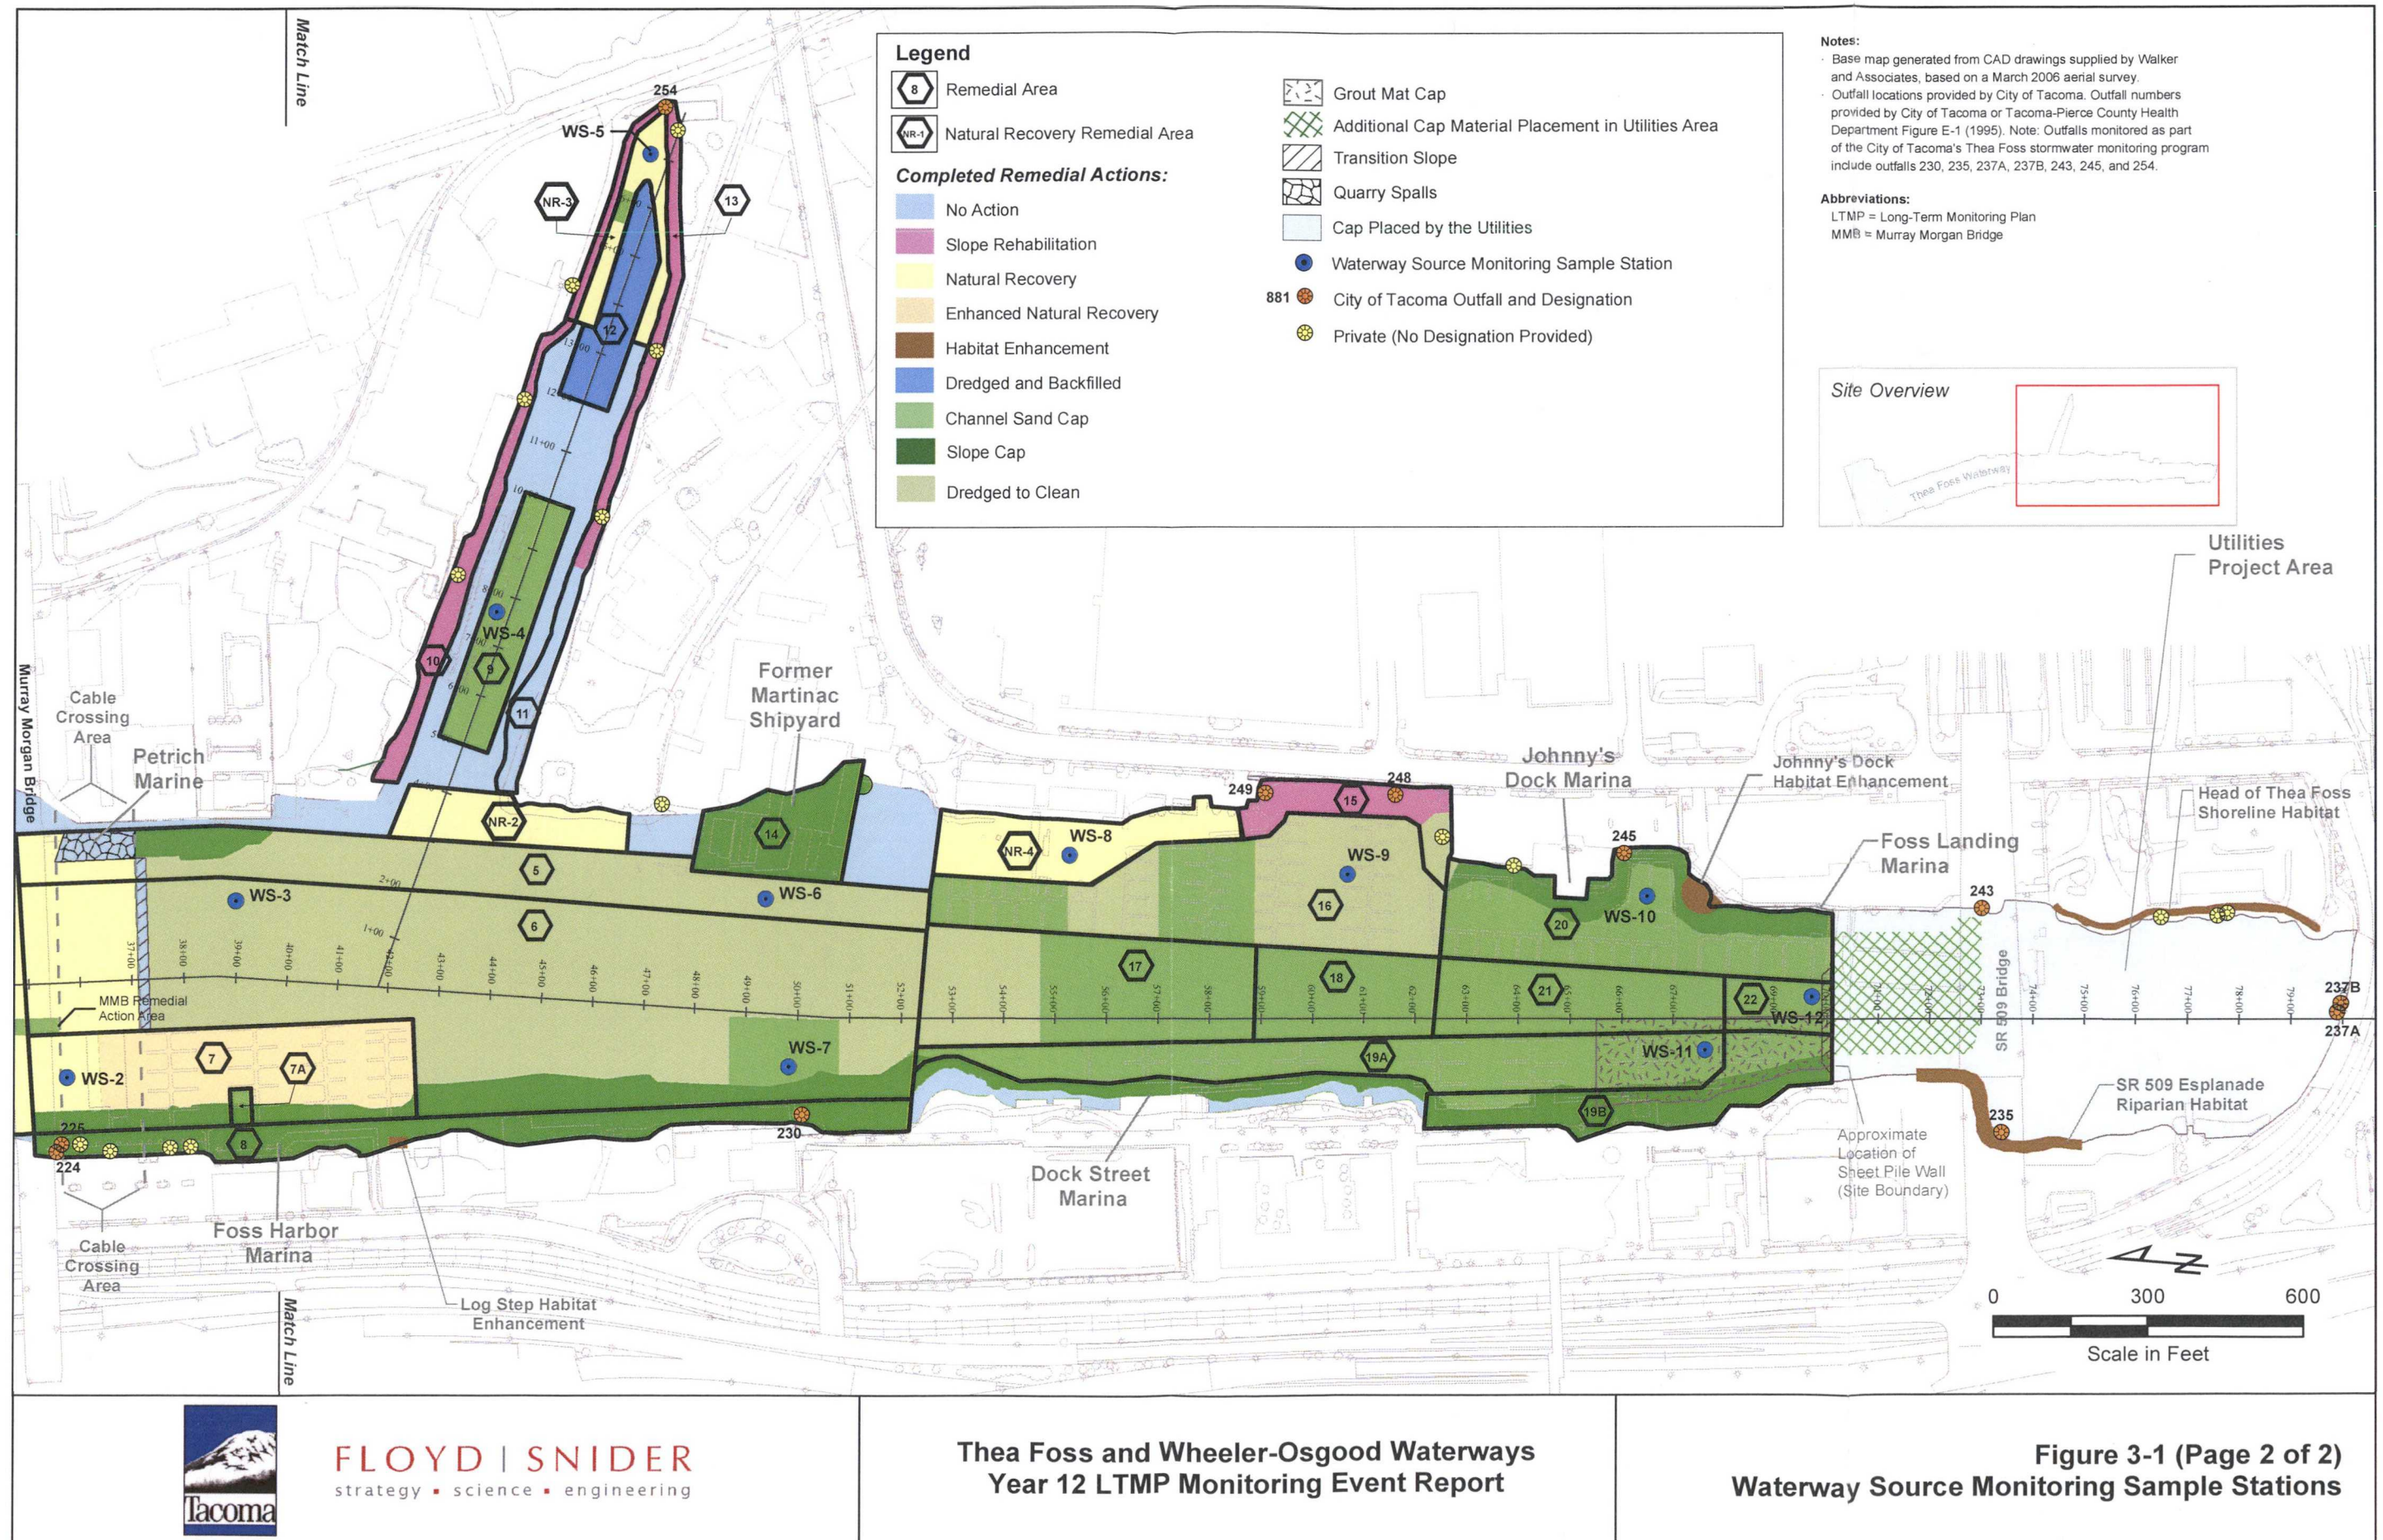
Figure 3-1 (Page 1 of 2)
Waterway Source Monitoring Sample Stations

Additionally, as part of the Year 12 LTMP monitoring activities, two waterway source monitoring sediment samples (WS-4 and WS-5) were collected within the Wheeler-Osgood Waterway adjacent to the two slope rehabilitation areas containing this sheen (refer to Figure 3-1). These two sediment samples were also analyzed for HPAHs and the concentrations of the HPAHs present in these sediment samples were all much less than their respective SQOs (refer to Table 3-1), indicating that HPAHs are not of concern in this area.
